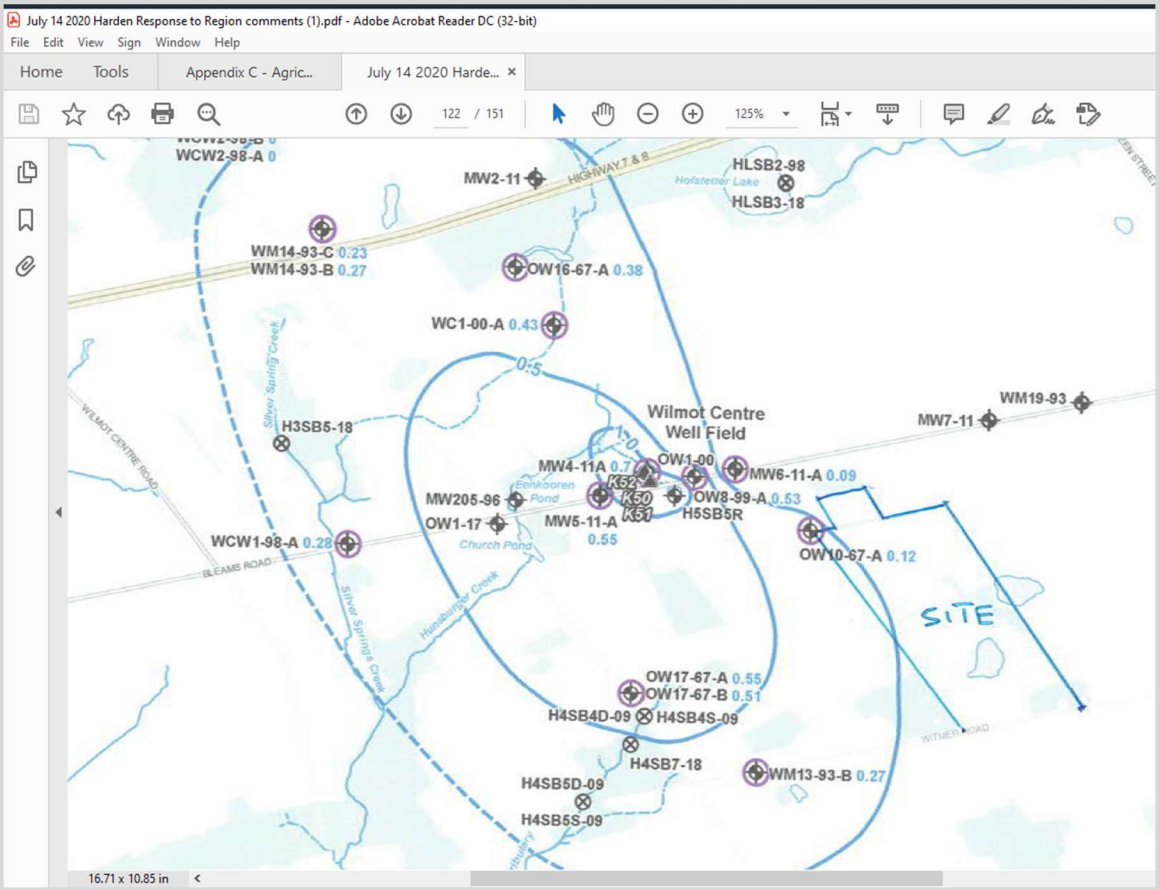
Figure 3: Monitoring well MW5 missing in the Nitrate study

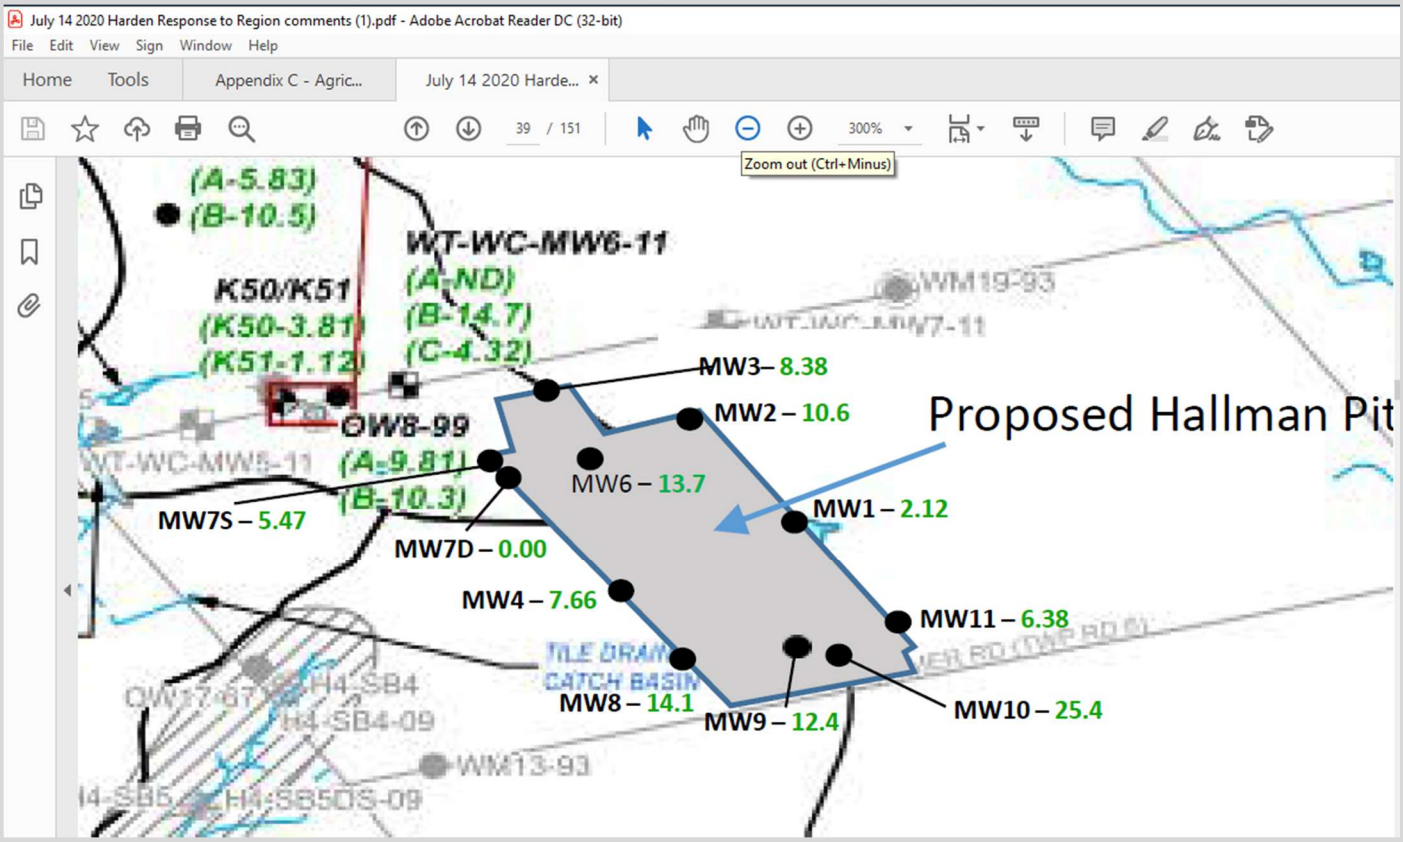
Figure 4; Well maps not consistent across reports see Figure 5

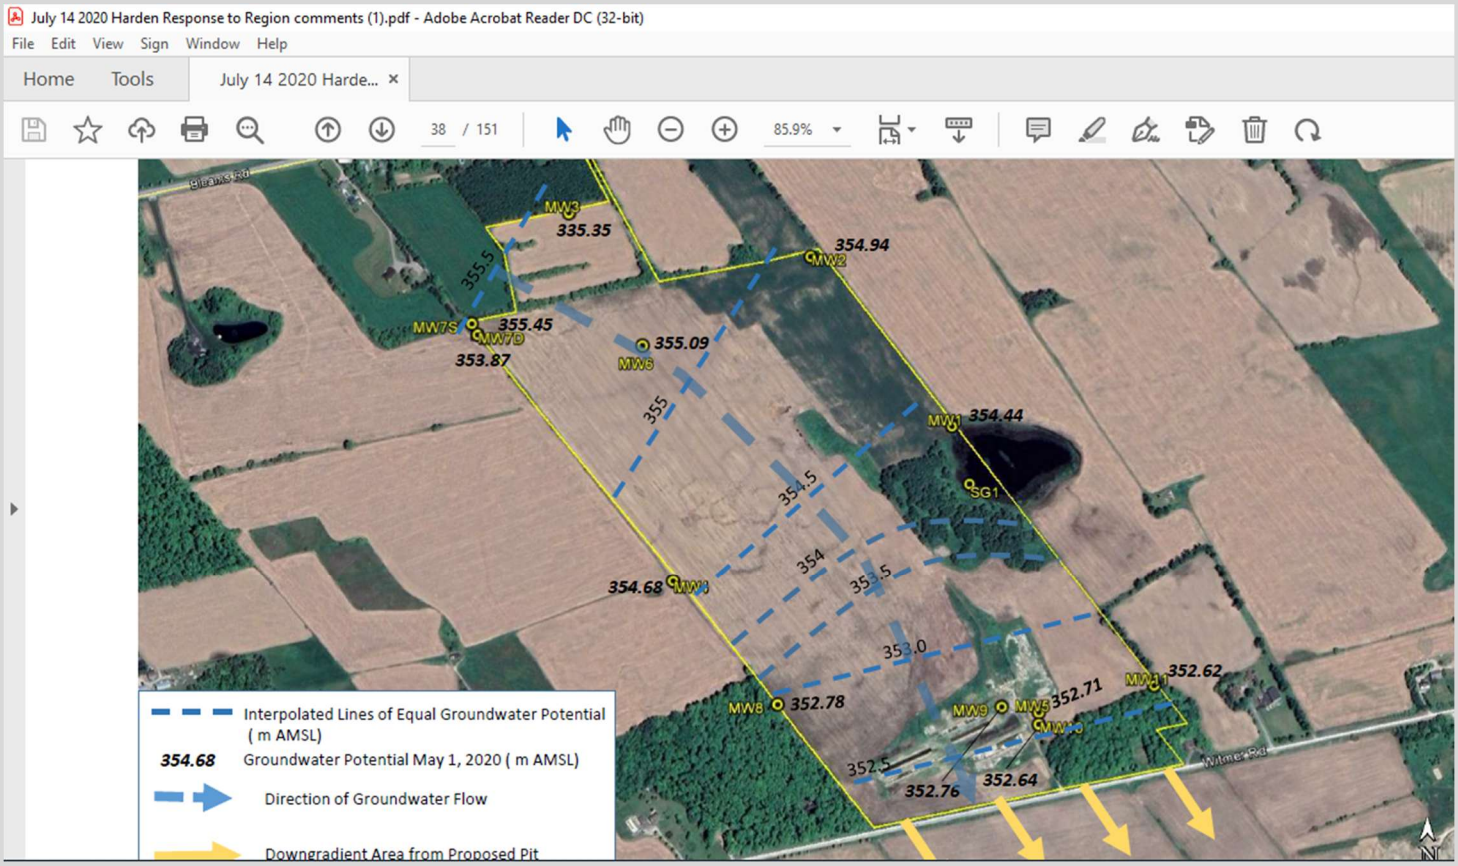
Figure 5; No legend provided for this map. Well A1 and A2 not identified.

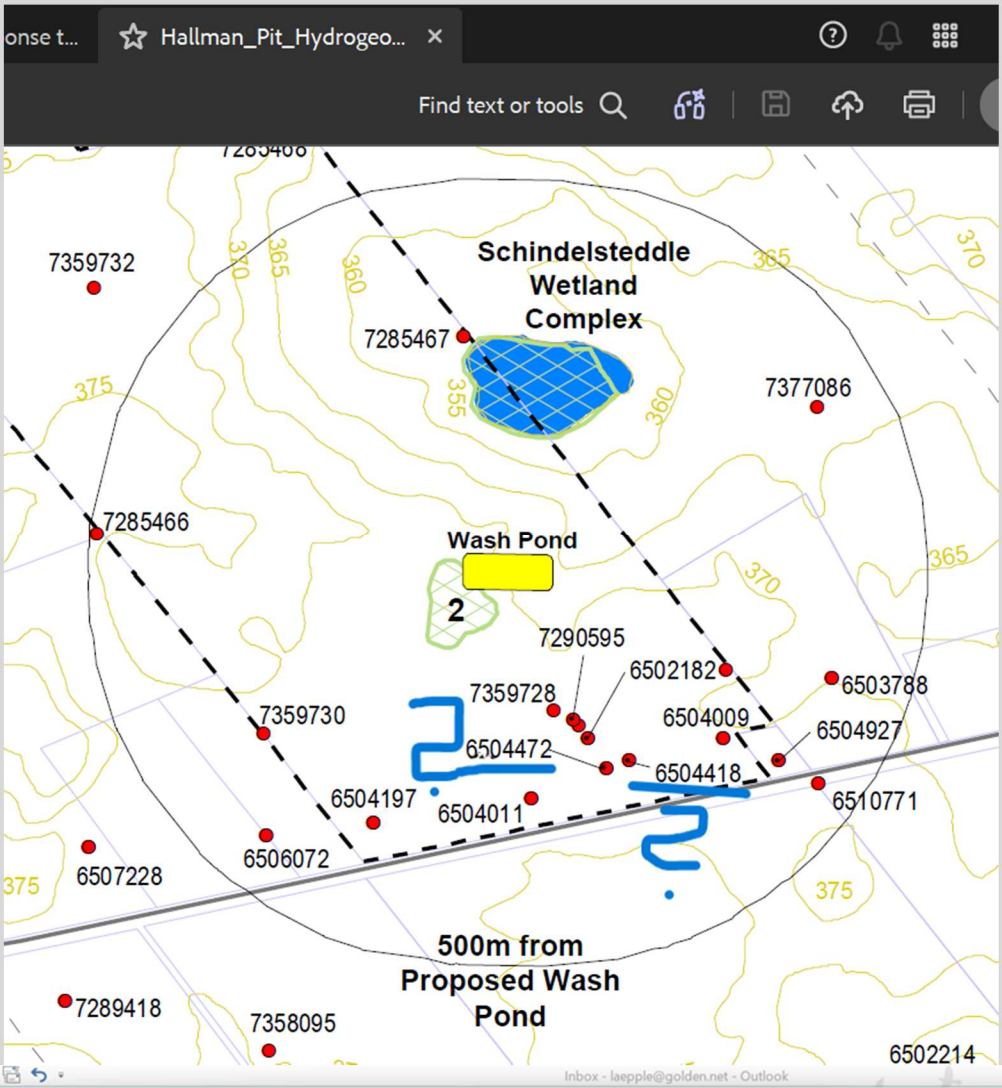
Of special interest are well #6504472 with a depth of 106.1 meter and rated 60GPM (gallon per minute) and irrigation well # 6504418 with a depth of 121.9 m. rated 600 GPM located near the wash pond area, see figure 7.

Figure 7; 2025 Hallman pit. Unaccounted Irrigation well in blue circle .
